SKYLAB MISSION REPORT
FIRST VISIT

PREPARED BY
Mission Evaluation Team

NATIONAL AERONAUTICS AND SPACE ADMINISTRATION
LYNDON B. JOHNSON SPACE CENTER
HOUSTON, TEXAS
August 1973

This report constitutes the Johnson Space Center's evaluation of the first visit. The report is presented in two parts, and contains the information available 30 days after the completion of the first manned visit.

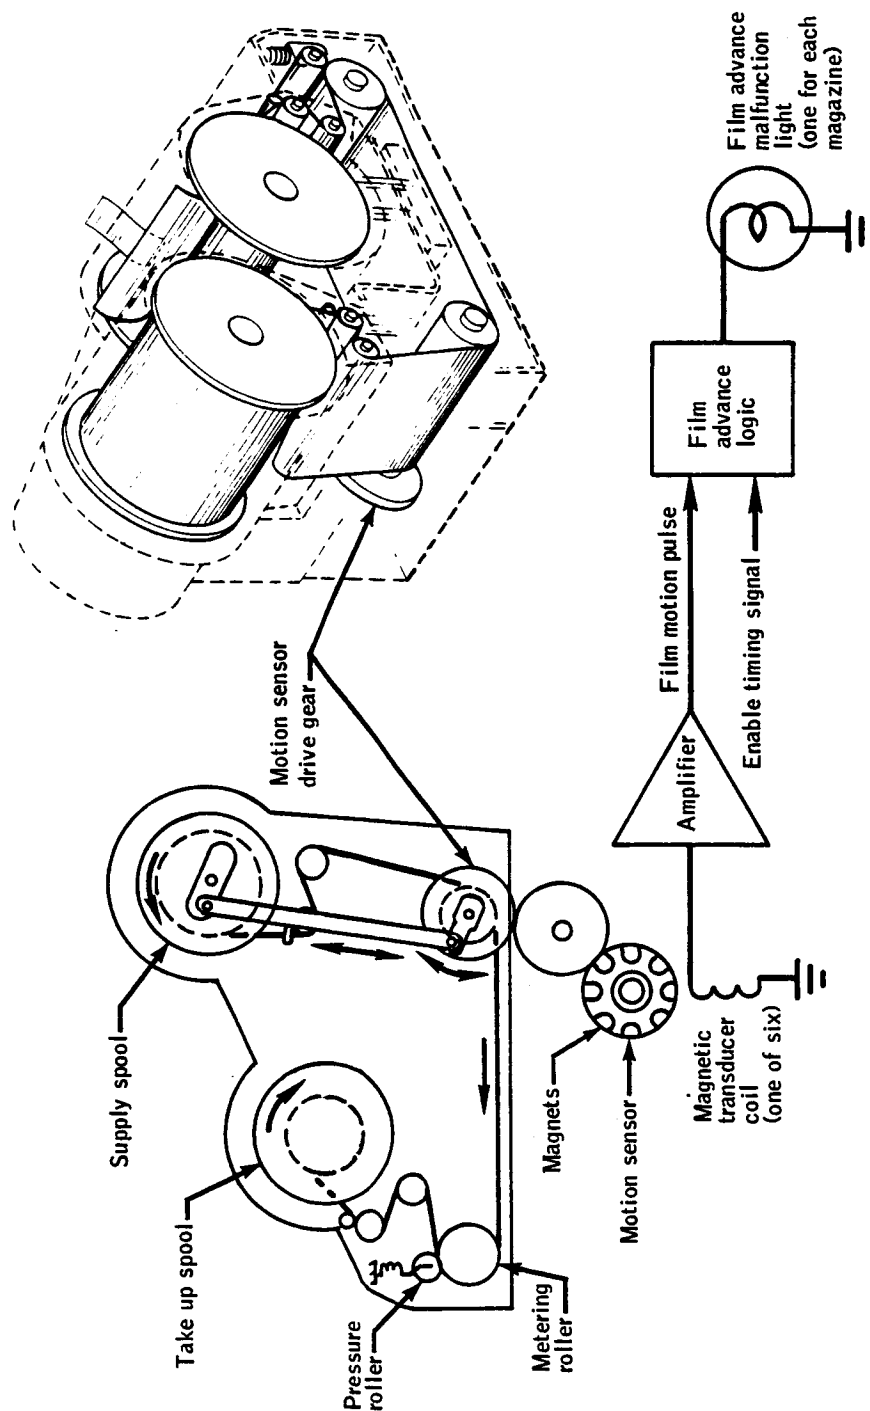
Figure 17.2-2.- Experiment S190A film motion sensing mechanism.

The experiment S190A film is wound on spools and loaded into cassettes, which are then loaded into magazines for use. Once the cassette is loaded into the magazine, the film is held so that it cannot unwind on the spool. Before loading into the magazine, the film leader is taped to the outside of the cassette to prevent it from slipping back into the cassette, however, the spool is free to rotate in the cassette.

All of the film associated with malfunction lights was launched in cassettes which were not loaded into magazines. The spools must have rotated within the cassette permitting the film to loosen prior to cassette loading into the magazine.

A piece of tape will be placed on the end of each cassette to be carried for the second and third visits to prevent the spool from turning within the cassette.

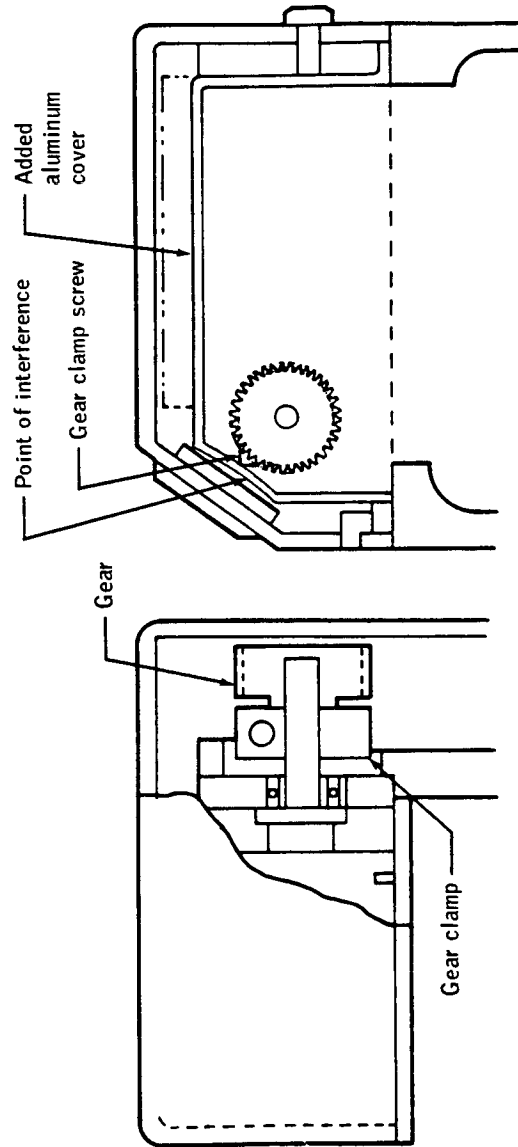
Figure 17.2-4.- Experiment S019 mirror tilt gear train interference.

A protective cover was installed over the digital display gear train just prior to stowing the experiment for launch to prevent the digital display numbers from reaching the gears, should the numbers have come loose. The protective cover was made of 0.4 millimeter sheet metal and had tabs bent at right angles to the cover.

The gear box cover was removed during the flight to inspect for the cause of the problem. The protective cover interfered with the gear clamp screw (fig. 17.2-4). The cover was straightened and the tilt mechanism then functioned normally.

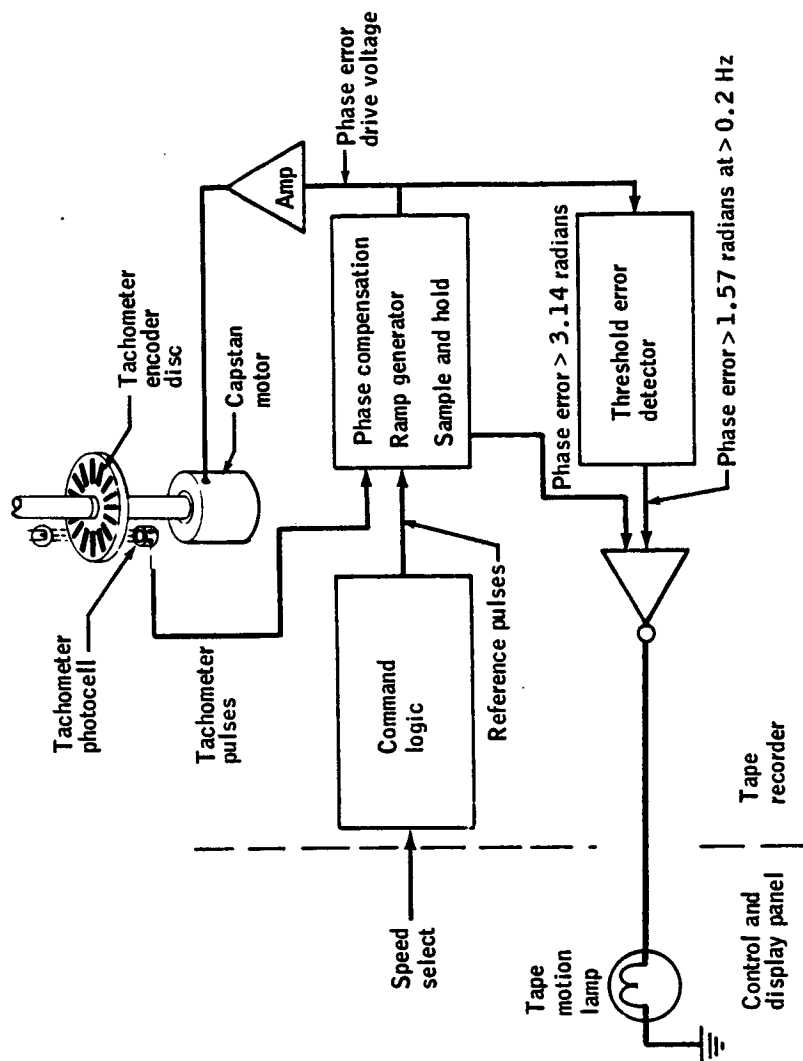
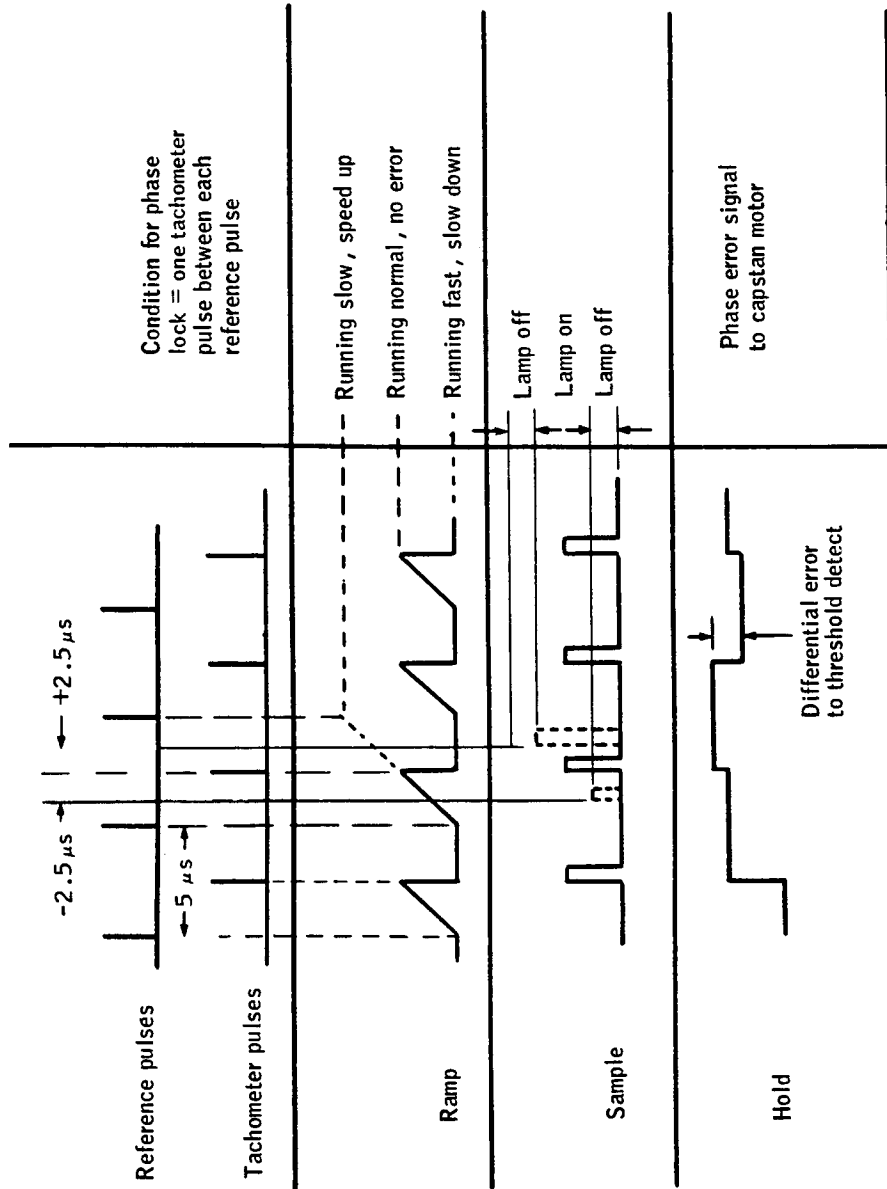
The basic requirement of phase lock synchronization (figs. 17.2-6 and 17.2-7) is that exactly one tachometer pulse occurs between two reference pulses. When this state is achieved, a ramp signal is generated. The ramp begins with the reference pulse and terminates with the tachometer pulse. At the termination time, the ramp voltage is sampled by a sample and hold circuit. The sample and hold circuit output voltage is proportional to the phase error between the reference frequency and the tachometer frequency, and is used to control the capstan drive motor speed. The phase offset is adjusted to time center the tachometer pulses between the reference pulses. Under initial starting or slow running conditions, the phase error voltage is high, causing the capstan to speed up until tachometer pulses occur between reference pulses. For overspeed conditions, the phase error voltage remains low, causing the capstan motor to slow down.

The tape motion light circuitry monitors the phase error voltage. At 152.4 centimeters per second tape speed, the tape motion light goes

off, if the phase error exceeds 3.14 radians steady state (phase slipping) or if the phase error is varying at a frequency greater than 0.2 hertz and the peaks exceed 1.57 radians phase difference.

The increased phase error implied by the intermittent blinking tape motion light is characteristic of a slight and erratic increase in frictional drag which causes a small and erratic variation in capstan drive motor speed.

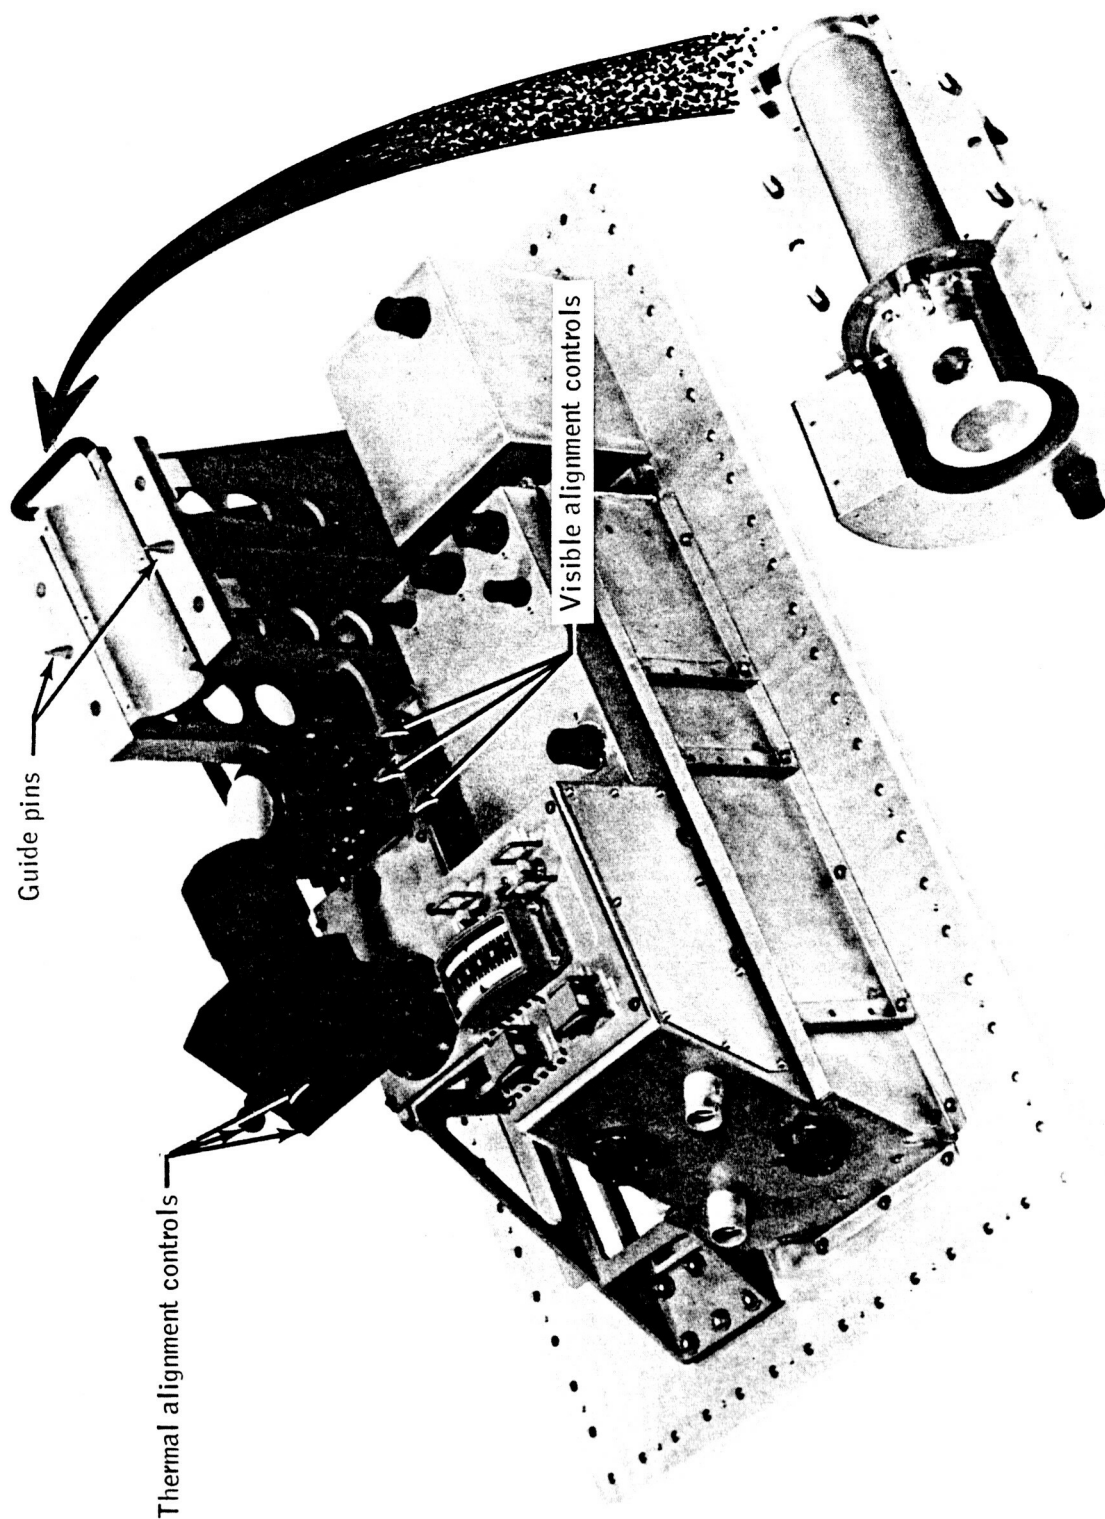
Figure 17.2-15.- Internal scanner and detector dewar assembly.

The only factor which could account for all of the abnormal conditions is something loose in the internal scanner assembly.

There are three mating points which, if loose, could cause the observed conditions. They are the optical bench to the adapter plate for the Multiple Docking Adapter (fig. 17.2-15), the detector dewar assembly flange to optical bench brackets, and the dewar housing to circular bolt flange. The most probable loose point is the detector dewar assembly mating to optical bench brackets. The capture of the nut by the differential screws (fig. 17.2-15) can lead to an improper mating. Assuming the nut is not engaged in the first two turns of the screw, 2.5 centimeters of travel into the flange is lost because of the differential threads. This would permit the shoulder of the screw to contact the upper flange, giving a tight feel and leading to a false impression of tight mating of the flange. Improper engagement of the differential screws has occurred during ground testing.

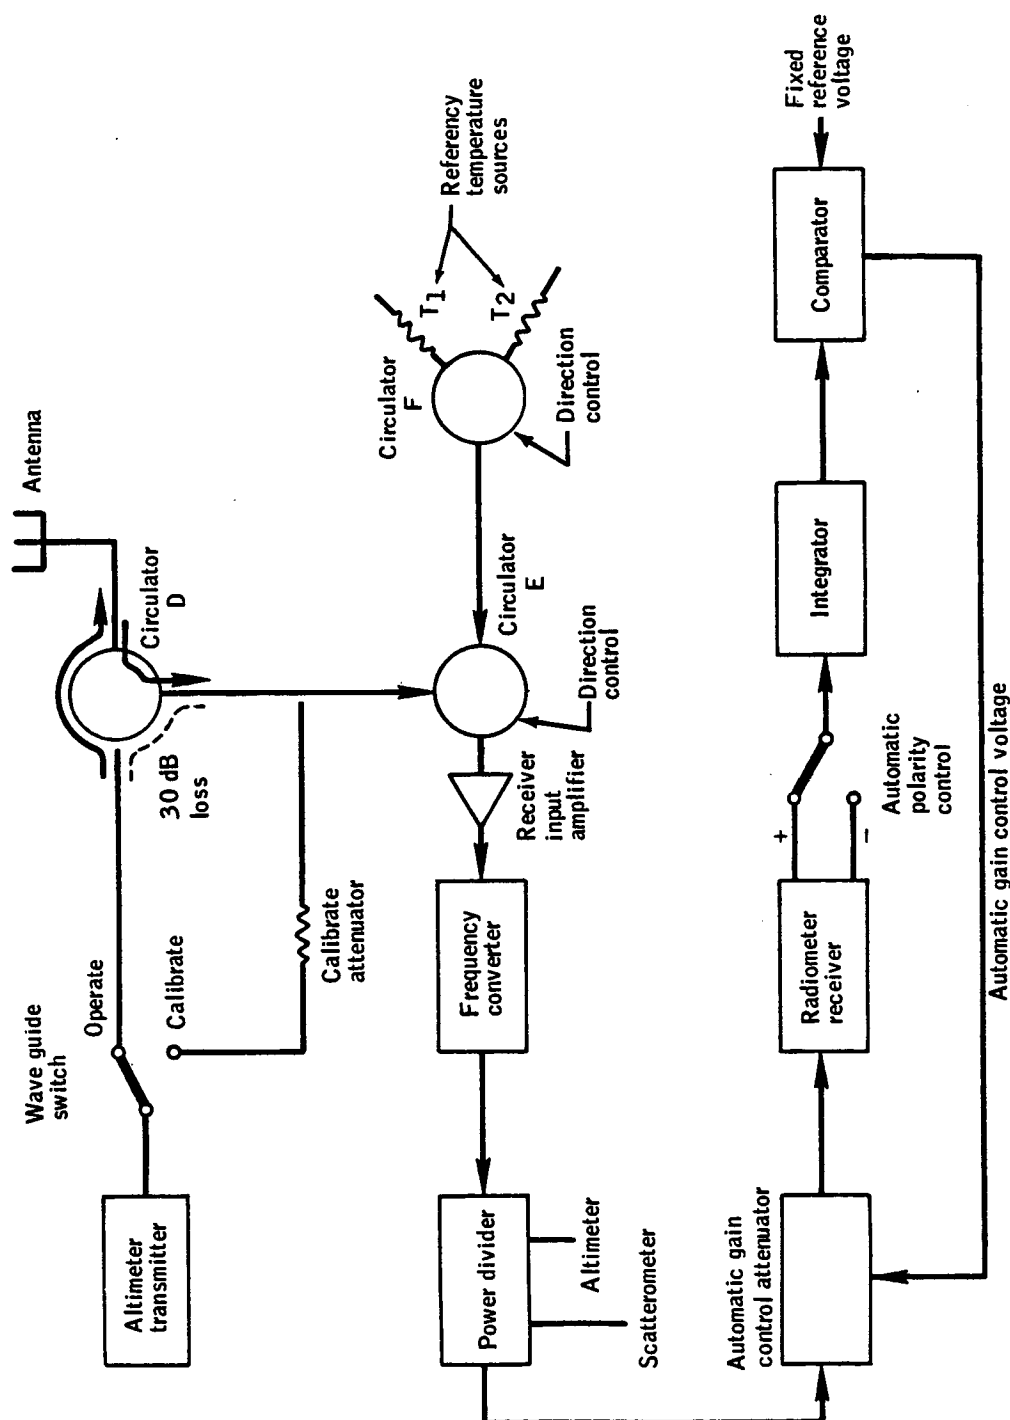
Figure 17.2-18. - Radiometer automatic gain control circuits.

During radiometer operation, energy radiated by the earth and received by the antenna is supplied through circulators D and E to the receiver input circuit and then to the radiometer receiver. To control the radiometer receiver gain, the direction of circulator E is periodically reversed, coupling the output of circulator F through circulator E to the receiver input. At this time, circulator F direction is commanded counterclockwise and the noise voltage from temperature reference (T_1) is supplied to the receiver. The voltage is demodulated and supplied through the receiver polarity control switch to an integrator (fig. 17.2-18). At this point, the polarity control switch is in the positive position and the receiver positive output is integrated for a fixed time period. Circulator F direction is then commanded clockwise and temperature reference (T_2) noise voltage is coupled to the receiver. Also, the polarity control switch is commanded to the negative position and the integration continues for an additional time period equal to the original positive integration period. The integrator output voltage at the end of the two integration periods is then proportional to the temperature difference between the two reference temperature sources. This voltage is compared to a fixed reference voltage and an automatic gain control voltage is developed. This voltage is used to control a variable attenuator on the receiver front end, controlling receiver end to end gain.

During altimeter operation, the radiometer was left in standby. In this condition, the radiometer automatic gain control circuit operated and attempted to control radiometer receiver gain. However, since each circulator supplies only 30 dB of attenuation between the input port and the port which is uncoupled from the input port, enough transmitter energy was coupled through circulators D and E to the receiver input to cause the automatic gain control to saturate. When the altimeter was turned off and the radiometer was switched to operate, the automatic gain con-

trol circuit, because of its long time constant, took about 30 seconds to come out of saturation and the first 30 seconds of radiometer data were lost (radiometer operate periods are normally about 1 to 5 seconds long). This operation was duplicated with the backup flight hardware.

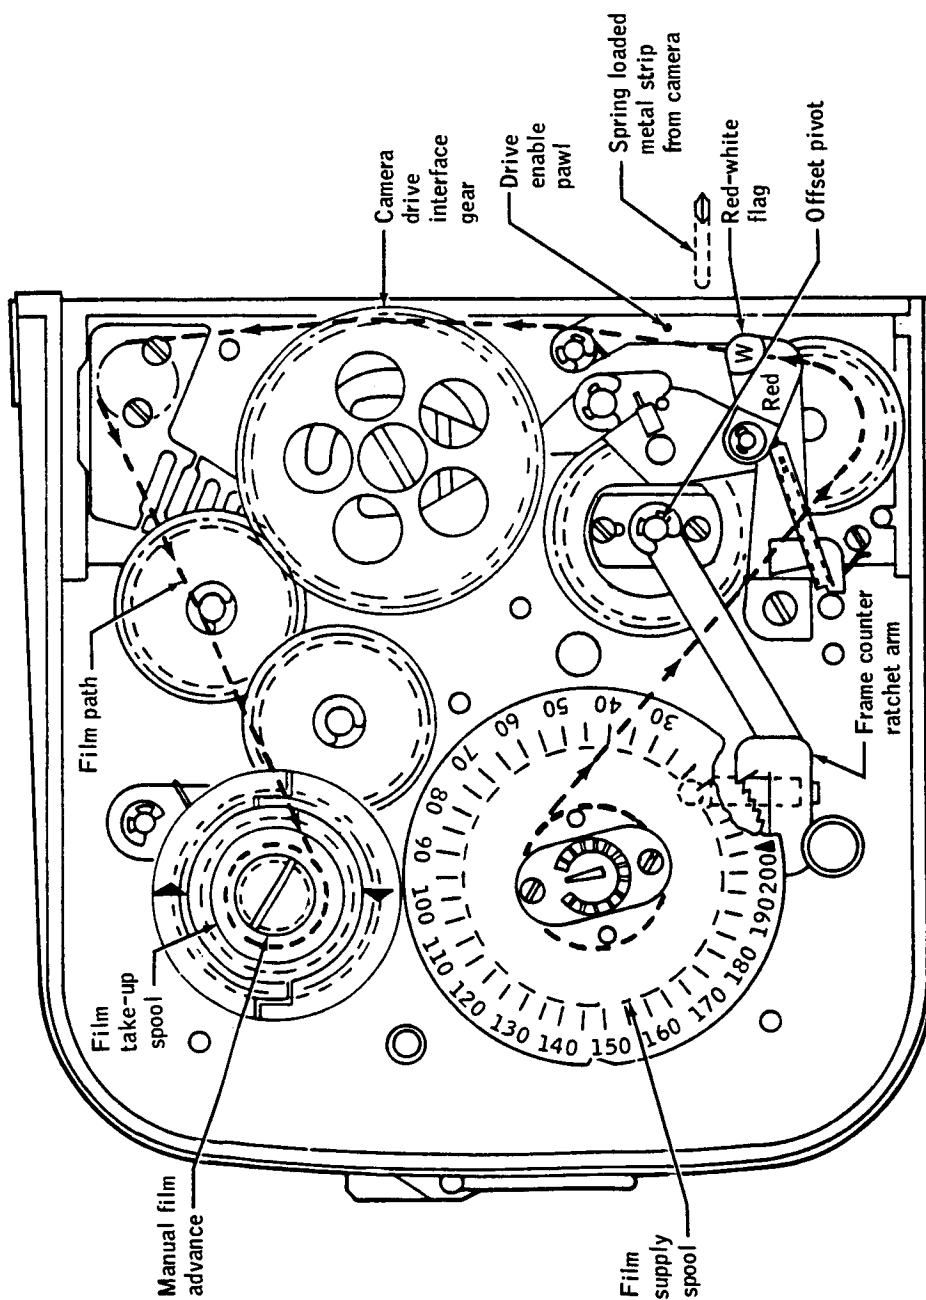
Figure 17.3-1.- Magazine for 70 mm camera.

Two possible causes existed for failure of the camera to operate. One is that the film is out of synchronization. The other is a blown fuse. The fuse protects the camera motor in case of a hard jam of the gear train or film.

Postflight inspection of the magazine revealed a red indicator under the window, showing that the film advance was out of synchronization at the time the magazine was removed from the camera. This evidence is not conclusive in selecting which of the two causes of failure is responsible, because a fuse can be blown in the middle of a cycle. This magazine was

mated with the flight camera, manually advanced to a white flag and then cycled to film depletion with no further anomalies.

The flight camera stopped in the middle of a cycle and a red flag was noted during an inflight frame advance. The magazine was removed from the camera and the operate button was depressed with no response, indicating a blown fuse. The fuse was replaced, the magazine remated, and the film was manually advanced until the white flag was present. At this point, normal camera operation was restored. The camera was used for several more frames when the camera again stopped. The crew replaced both the magazine and fuse to insure proper operation of the camera.

Development of the film showed that the first stoppage was at frame 62. This is evidenced by a white over exposure. Following this, ten good pictures were noted and at frame 72, the second stoppage occurred.

A search, using magnification, of the gear compartment was made for debris which could possibly have caused jamming and the attendant fuse blowing, but no debris was found.

The developed film was inspected for evidence of emulsion sticking, tears, and other physical deterioration which might have caused jamming. No evidence of any of these conditions existed.

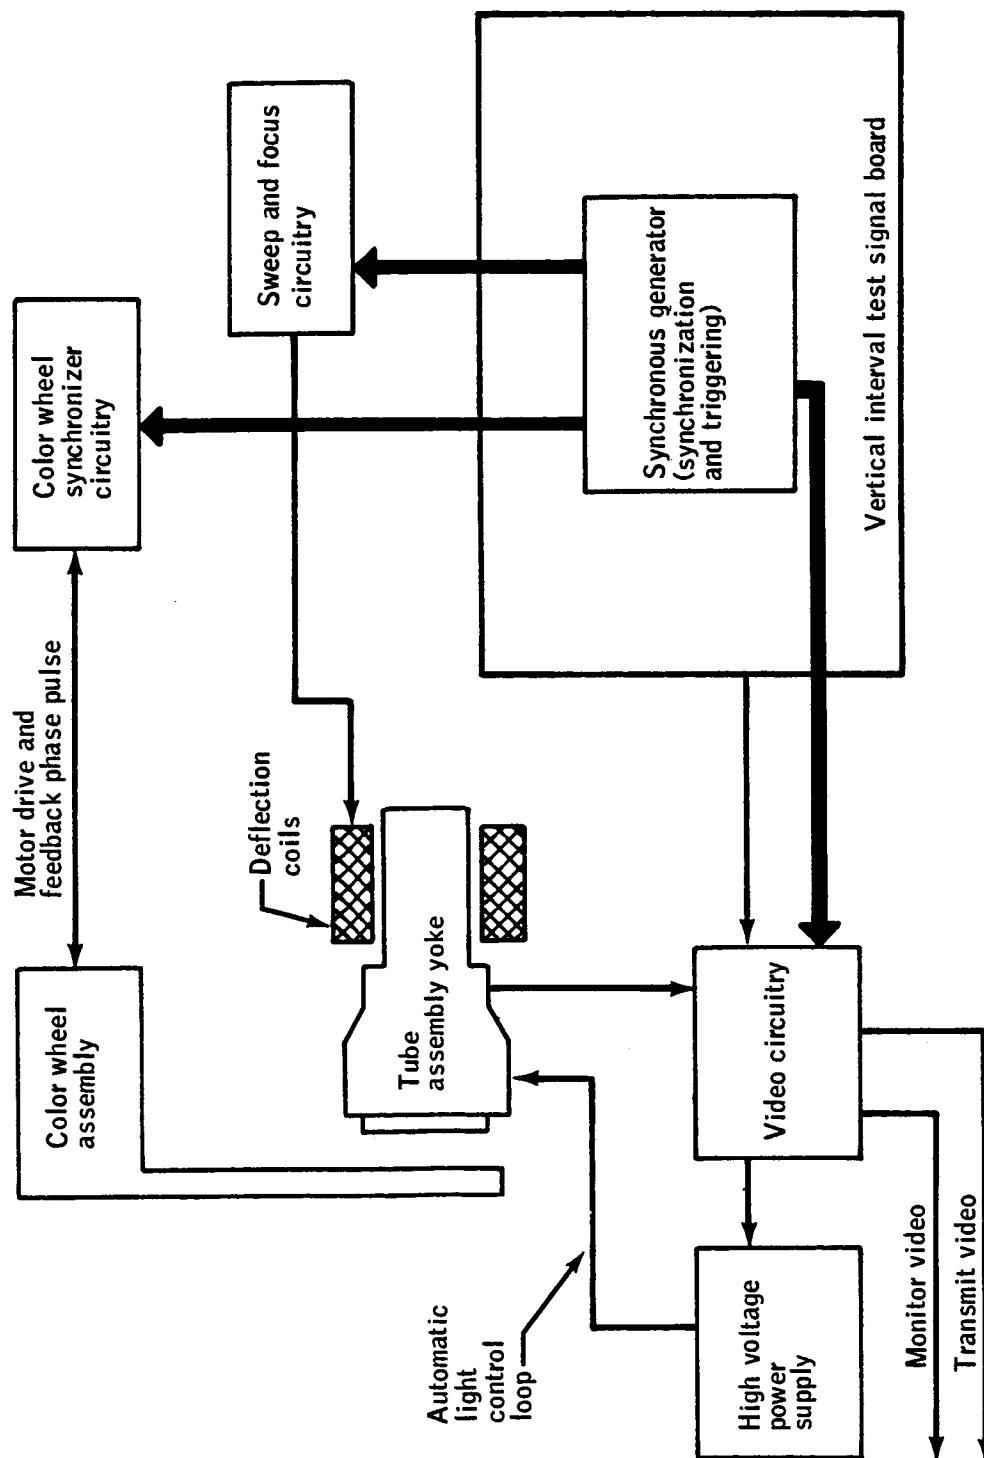
Figure 17.3-2. - Simplified color television camera loop synchronization and triggering.

The crew reported that portable television camera (serial number 3005) had failed at 20:03 G.m.t. on visit day 9. The camera had been running and showing a good picture on the monitor, but abruptly ceased operating as the camera was being moved. The zoom lens was removed and the color wheel was not turning. About 25 hours earlier, the camera had been accidentally kicked which caused a collision with and rebound from the wall of the Orbital Workshop forward compartment.

The television color wheel drive train motor (fig. 17.3-2) is kept in proper video phasing by the color wheel synchronizer circuitry. This circuitry is triggered and synchronized by timing signals received from the synchronous generator. The synchronous generator also provides triggering and timing signals to the sweep and focus circuitry that generates the horizontal sweep, vertical sweep, blanking, and magnetic focus signals for the tube assembly yoke.

Postflight testing verified the failure was in the multichip hybrid synchronous generator package. No synchronizing signals were being generated, thus depriving the entire camera of triggering and timing signals. Without timing, there is no color wheel drive phasing signal, the tube assembly deflection coil sweep is not properly generated, and the video processing circuitry will not function.

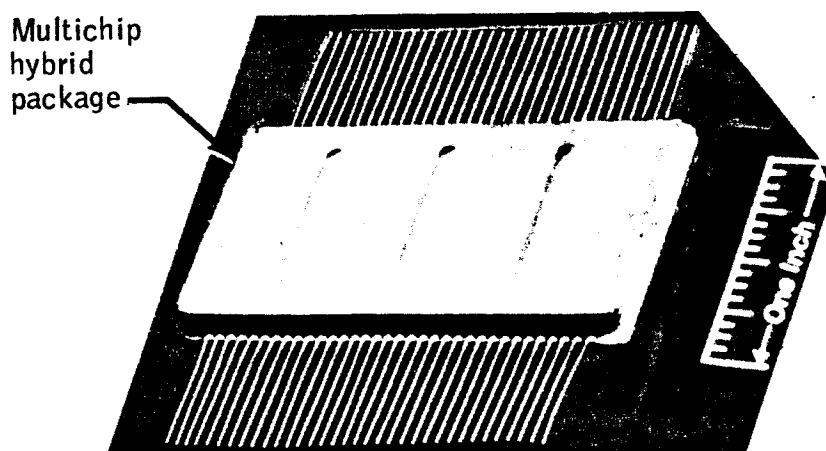
Figure 17.3-3.- Synchronous generator.

The generator multichip hybrid package was operative however, after removal from the camera, and also after re-installation in the camera. The package was again removed and vibration tested, during which sensitive microphones detected the sounds of loose internal particles.

The package was opened and particulate contamination was found on the substrate and logic chips. The individual chips were insulated by a glass coating, but the interchip conductors were exposed and are subject to shorting by conductive contamination.

Tests showed the contamination was mostly tin and silver with minute traces of copper and gold. The tin and silver are solder constituents. The gold trace probably flaked off the substrate and the copper trace is foreign to the package. (The package had been opened two times prior to flight for repairs.) Since the package now operates, and the particulate contamination has been disturbed, it is not known which sub-circuit was shorted.

The television camera failure was probably caused by tin/silver solder particles within the synchronous generator multichip hybrid package that were introduced during the two repair operations prior to flight. Furthermore, not all of the camera multichip hybrid packages were screened on the acoustic vibrator for contamination.

(b) Synchronous generator with lid intact.

The two television cameras to be flown on the second visit will not have their multichip hybrid packages removed for testing for contamination. Such action would require extensive disassembly of the cameras. Each camera contains twelve packages and the disassembly would most likely result in lowering the camera reliability. Further this was the first such operational failure.

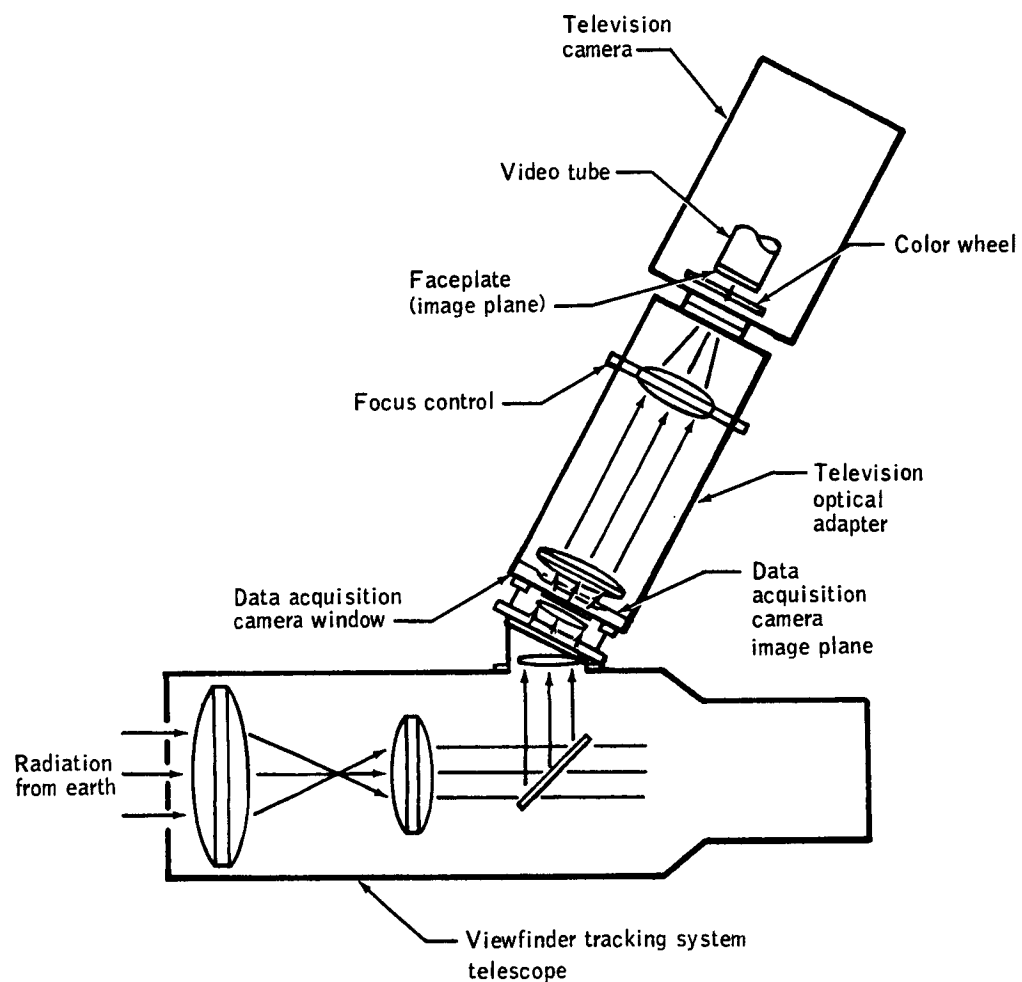
Figure 17.3-5.- Television camera configuration used with viewfinder tracking system telescope.

Two types of spots were observed. The first spots were observed when the television camera was used with the optical adapter on the viewfinder tracking system during Earth Resources Experiment Package passes 9 and 10. The images had a pattern of an increasing number of blurred and sharply focused spots, mostly fixed with respect to the reticle.

The second group of spots were observed when the television camera was used with the zoom lens; the spots were blurry and in a fixed pattern that did not change in number or location.

shows that the entire telescope optical loop is probably free of contamination. However, the crew did remove contamination on the outside optical surfaces (data acquisition camera window and optical adapter outer lenses). Therefore, the sharply focused spots were caused by the particles the crew removed from the external surfaces, and the telescope internal elements are clean. The blurred spots observed on the television images were caused by the particles on the faceplate.

The degradation of picture quality is not significant and therefore, does not warrant color wheel redesign. If, after extended use, the number of spots on the transmitted images becomes significant, the spare camera can be used or the faceplate can be cleaned by the crew.

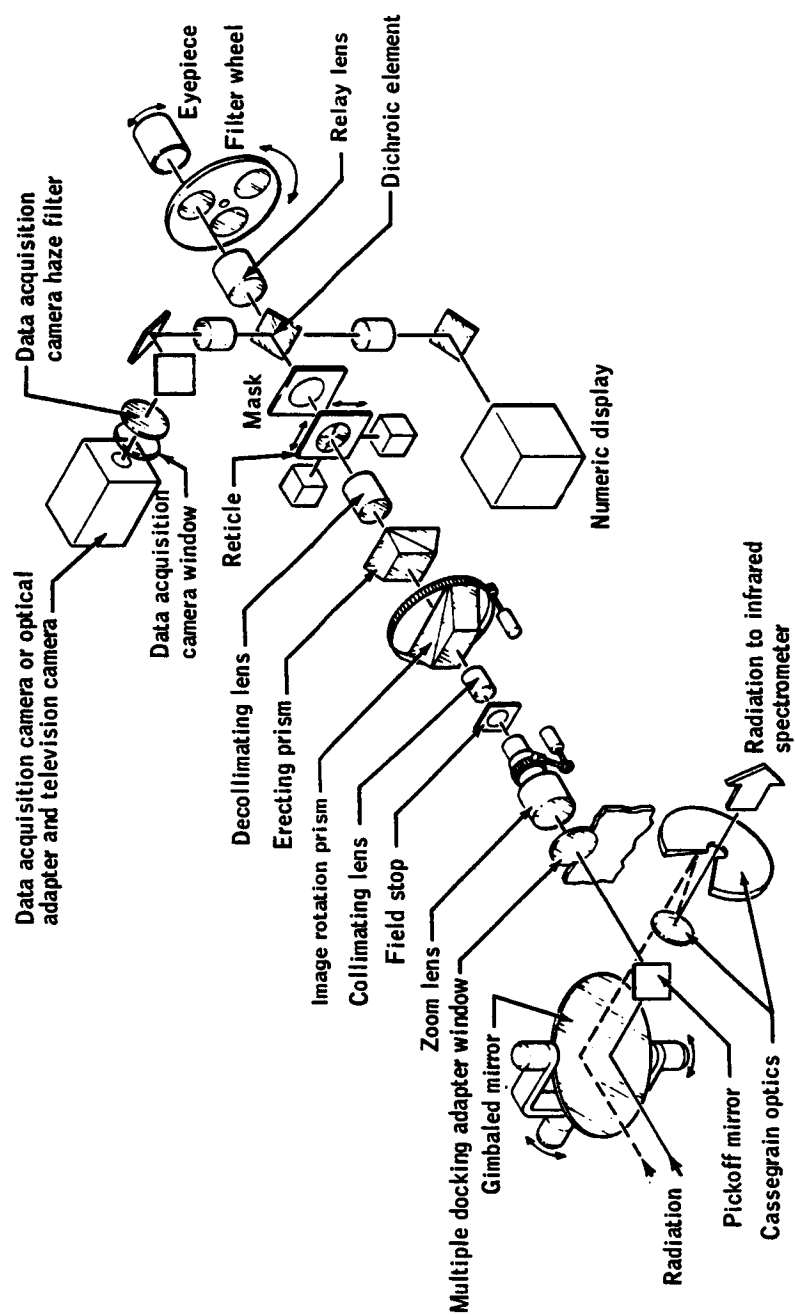
Figure 17.3-6.- Experiment S191 viewfinder tracking system optical diagram.

The inspection of the viewfinder tracking system by the crew did not disclose any spots through the eyepiece, nor was any contamination noted in the data acquisition camera photographs. An assessment of the contribution of the viewfinder tracking system telescope to the contamination

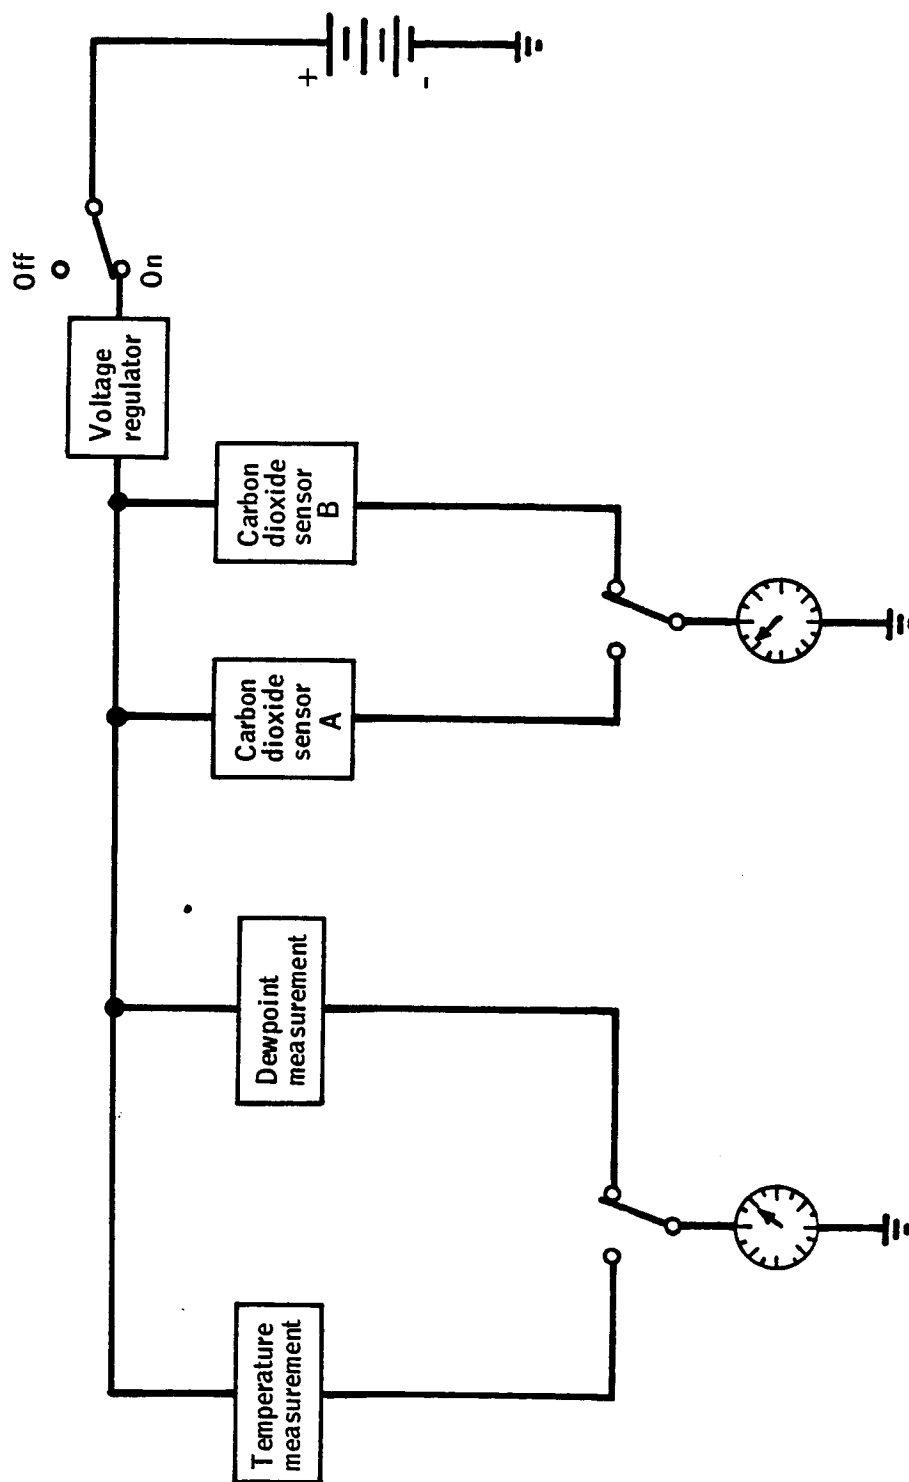
Figure 17.3-7.- Portable carbon dioxide/dewpoint sensor.

Early in the visit, a white residue was found around carbon dioxide sensor A of the portable carbon dioxide/dew point monitor. Measurements taken at that time disagreed with other onboard instrumentation in that sensor A indicated 160 newtons per square meter, sensor B indicated 1600 newtons per square meter, and the onboard reading was 640 newtons per square meter.

Seven days later, the crew used the carbon dioxide/dew point monitor to measure dew point. The measured value was 297° K and, at the same time, the onboard instrumentation was recording approximately 283° K, indicating that the dew point measuring portion of the unit had failed.

The carbon dioxide partial pressure readings taken on visit day 8 indicate that both carbon dioxide sensors were failed. The white residue noted around sensor A was most probably dried electrolyte that had been pulled through the membrane by exposure to pressures below the instrument design limit of 0.34 newtons per square centimeter. Development testing with these sensors demonstrated that electrolyte can be drawn through the membrane by exposure to pressures of approximately 0.17 newtons per square centimeter as were experienced on the Orbital Workshop during postlaunch venting to purge potential toxic gases. This depletion of electrolyte would cause a low carbon dioxide reading. The cause of the failure of carbon dioxide sensor B is unknown.

The dew point measurement on visit day 8, indicated that the dew point sensor was working at that time. However, the measurement which was made 7 days later indicated the dew point sensor was not working properly. Possible causes of this failure are an inoperative cooler, an inoperative light bulb, or failure of the dew point ambient temperature meter switch.
